West Sussex County Council Report on June 2012 Flood Event.

November 2012

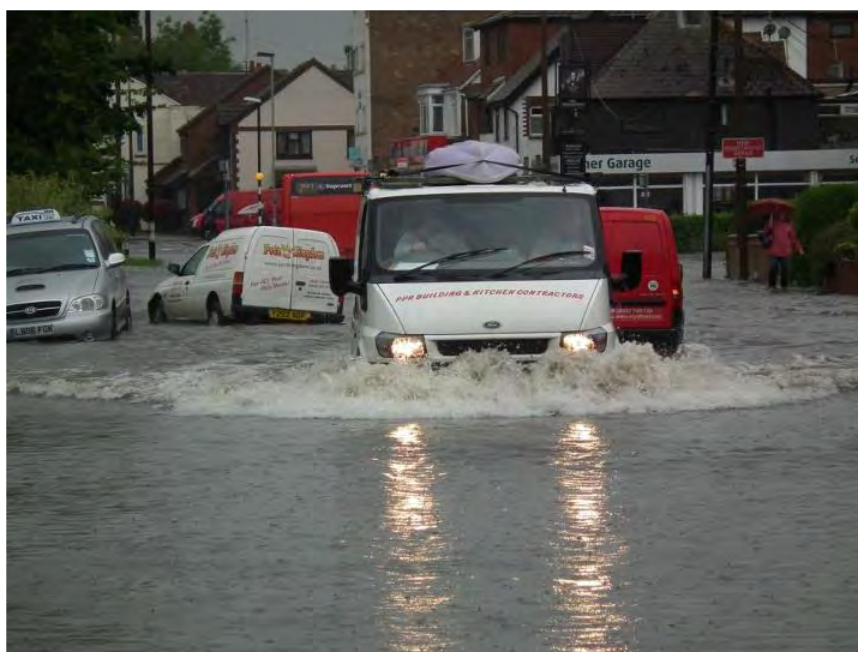
Figure 8 – Elmer Road, Middleton-on-Sea.

Southdean Drive/St Nicholas Lane/Tuscan Avenue is a similar problem as to Central Drive, etc, but exacerbated by the infilling of a ditch in the rear gardens of the properties on the western side of Southdean Drive, adjacent to the recreation ground. This ditch used to intercept surface water run off from the playing field. A short section of ditch still exists and discharges through a culvert that runs through the church carpark and churchyard, but there may be root intrusion issues in this culvert? The culvert then passes under Elmer Road, collecting highway drainage on route, before flowing through a WSCC maintained culvert under what appears to be a large storage ditch to the west of Lucking Lane. During the June event the section of culvert from Elmer Road north to the Lucking Lane footway was flowing slowly, this may indicate a problem with this section of culvert. The ditch above was very overgrown and in need of maintenance. There is thought to be connecting links between the ditch and the culvert beneath. WSCC have recently undertaken clearance of this ditch and revealed a significant amount of dumping from adjacent properties. This culvert, then discharges into the IDB ditches on the north side of Ancton Lane. It is believed from initial investigations that the IDB ditches are silted up and have standing water most of the year, which results in a restricted discharge from the culvert. The Environment Agency who act as the IDB in the area, will work closely with the other relevant authorities to investigate these potential issues further and develop a plan of maintenance to address them.

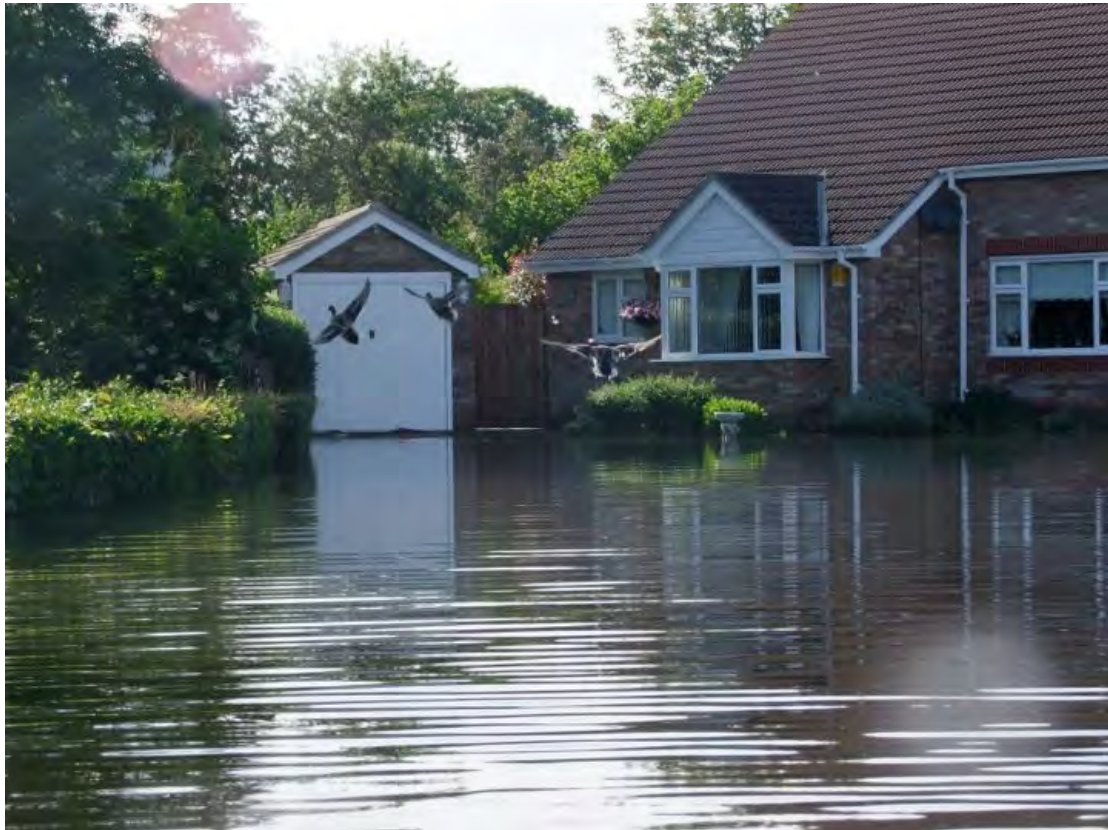
Figure 9 – Willowbrook, Middleton-on Sea.

- The outlet from Willowbrook is to the north through a culvert in the rear gardens of Ancton Close. The condition of this private pipe is currently unknown. There is a grille covering the entrance to this pipe which may have been partially blocked but obviously was not visible.
